State of the Regional Water System

Services of the San Francisco
Public Utilities Commission

September 2018

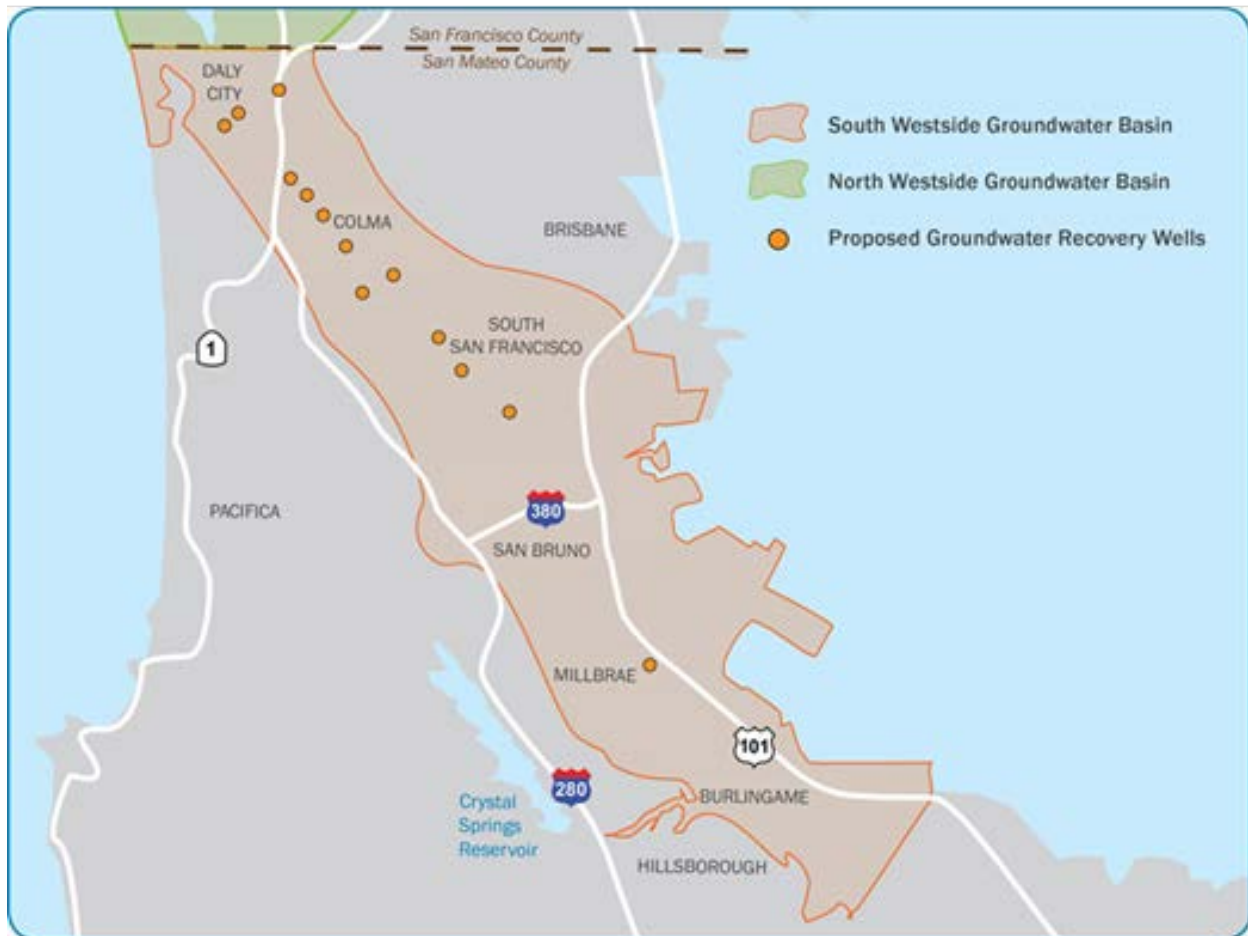
Figure 2-2: Location of GSR Groundwater Wells

Figure 2-2 shows the locations of the 13 new well stations in the southern portion of the Westside Basin. Nine of the thirteen wells connect directly to the SFPUC's RWS, two wells connect directly to the City of Daly City's distribution system, and two wells connect directly to Cal Water's distribution system. The well pump stations will begin commissioning testing in summer/fall 2018. As many as three test wells are being constructed in the southern portion of the Westside Basin to determine whether conditions are adequate to convert the test wells into GSR groundwater production wells. Construction of three test wells commenced in March 2018.

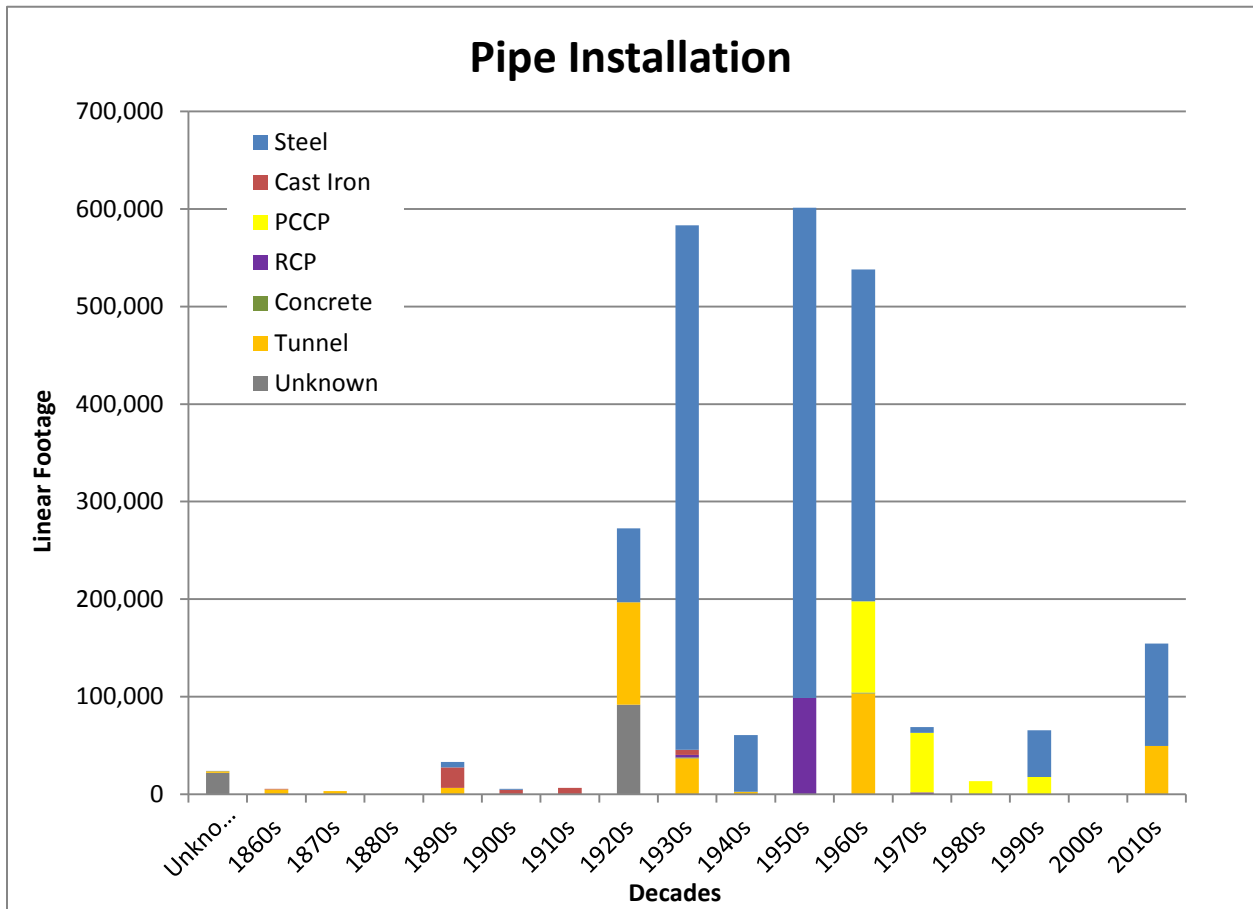
Figure 2-3: Linear Feet of Pipelines and Tunnels by Material and Installation Decade

Pipelines of the RWS west of the AEP range greatly in terms of installation date, pipeline material, pipeline condition, and operational importance. The current inventory is shown in Table A-6 in Appendix A. A graphical summary of pipeline and tunnel installations by material and installation date is shown on Figure 2-3. A graphical representation of cumulative pipeline and tunnel inventory by material and installation date is shown on Figure 2-4.

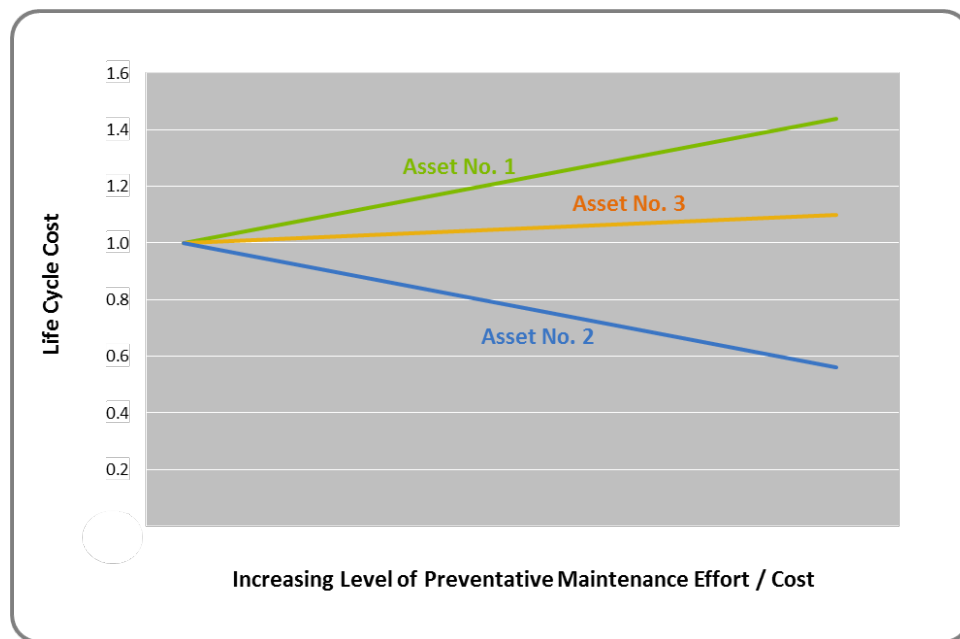
Figure 3-2: Preventive Maintenance Prioritization Methodology

The decision on whether and/or when to perform preventive maintenance (PM) is based on two objectives: to minimize unplanned outages (reliability) and to minimize life-cycle costs. For a given level of reliability, higher levels of PM can result in different life-cycle cost scenarios, depending on the asset. This is illustrated by the three hypothetical examples on Figure 3-2.

For hypothetical Asset No. 1, increasing PM activities increasingly adds to the overall life-cycle cost due to its low replacement value. The maintenance strategy employed in this case should appropriately be “run to fail” (assuming reliability is unaffected). Examples include off-the-shelf electronics and sensors, as well as inexpensive pumps or motors that require little or no PM.

For Asset No. 2, increasing PM activities continues to lower the overall life-cycle cost, a typical result for large-value assets. Investment in corrosion protection is an excellent justification for paying higher PM costs to reduce overall life-cycle costs. Without proper corrosion protection – which could cost as little as \$10,000 a year – a \$100-million pipeline can have its useful life reduced by 50 percent.

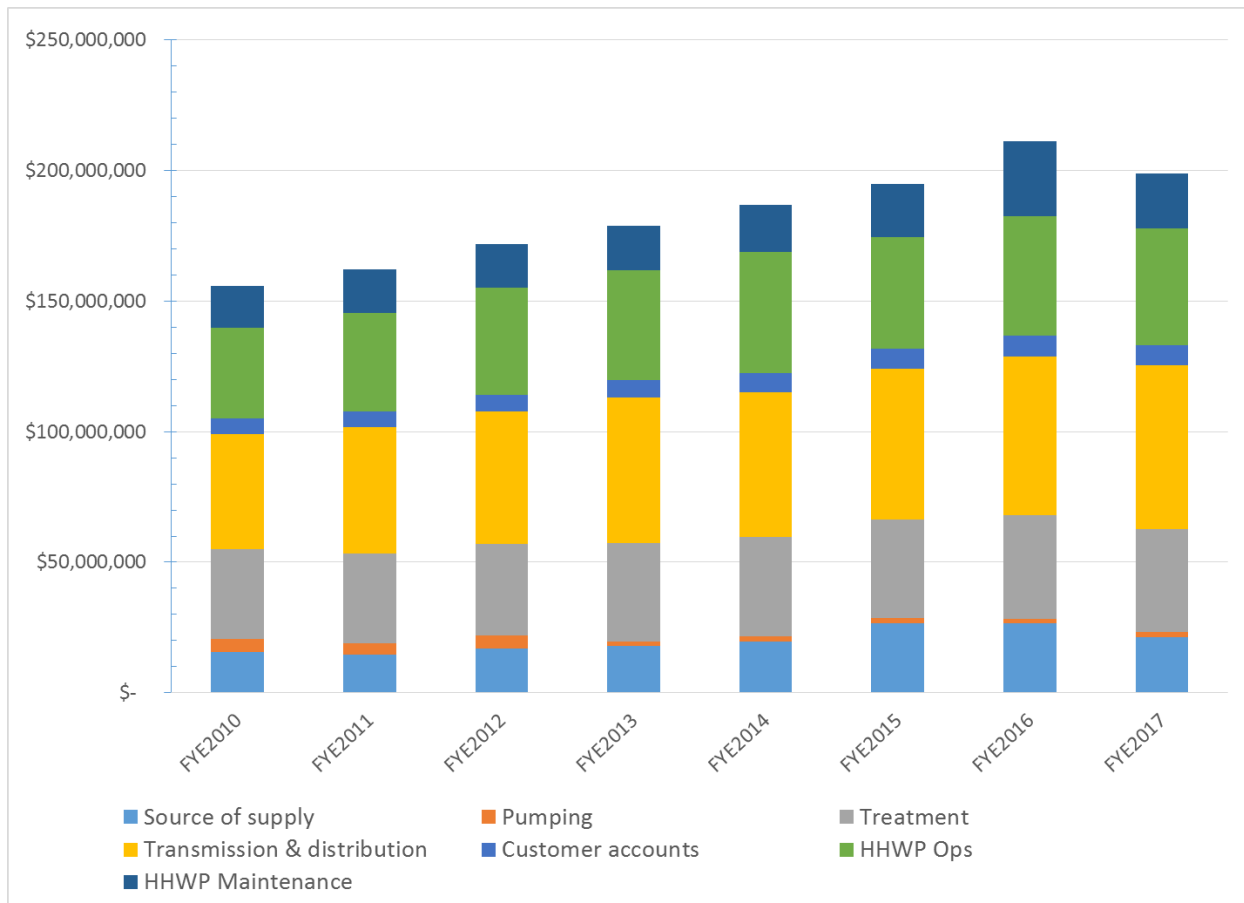
Figure 4-1: Historical Water Enterprise and HHWP Operations and Maintenance Expenses, as Reported in the Wholesale Revenue Requirement

As expected with new WSIP facilities coming online, O&M expenses, as shown in Figure 4-1, have been increasing steadily since FY10 at about 3.4 percent per year, which is more than the inflation rate. The increase has been slightly higher for HHWP than WSTD (3.7 percent versus 3.3 percent). This trend is expected to continue in the coming years.

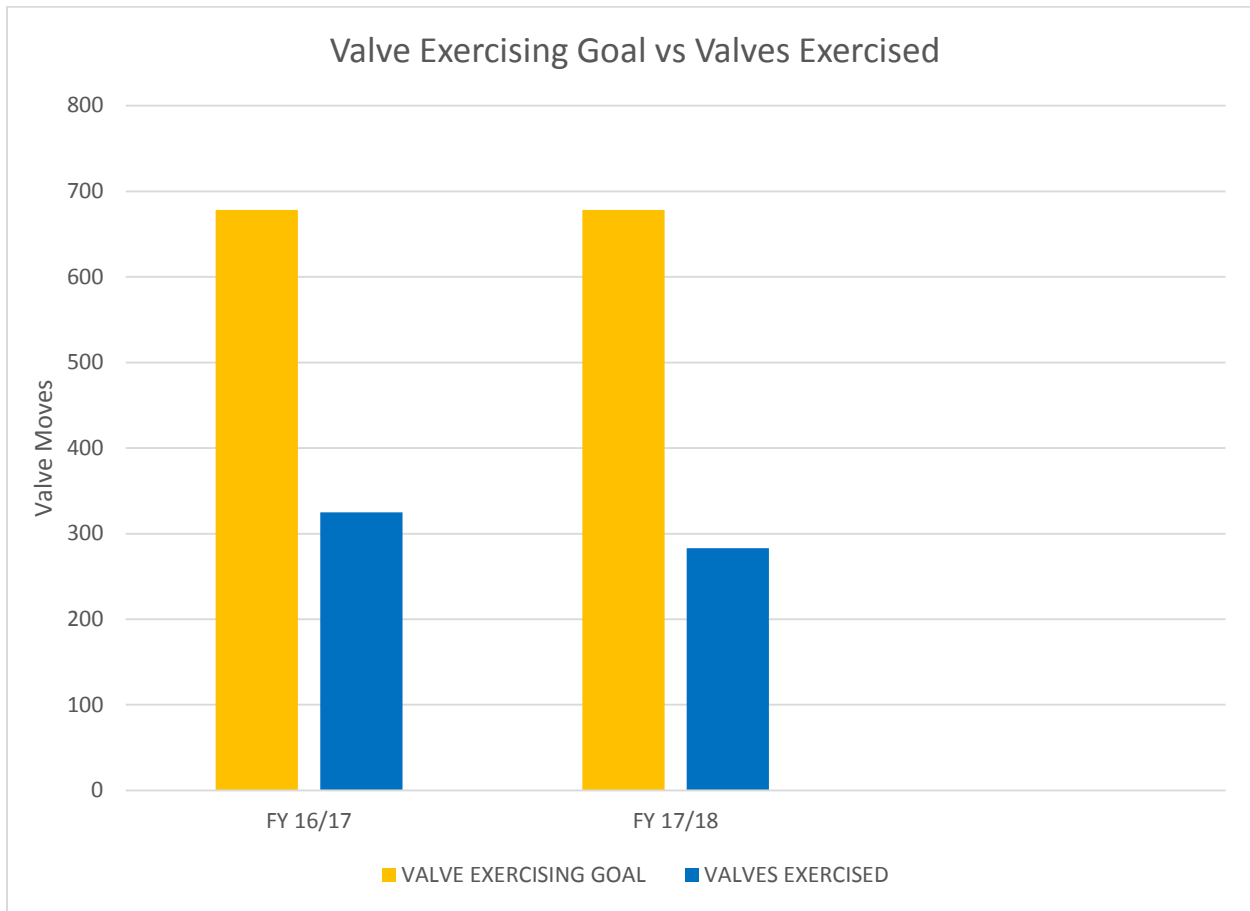
Figure 4-3: Number of Valves Exercised at HHWP in 2017 and 2018

HHWP has a similar valve exercise program. As shown on Figure 4-3, HHWP is not meeting their target. In 2019, HHWP will create schedule focus for completion of valves exercised by taking advantage and documenting the exercising of valves prior to rate changes or performing lock-out-tag-out. Similarly, if full operations of the valve will not disrupt system operations, the valve to be exercised is fully opened and closed. If full operation of the valve is not possible due to operational constraints, the valve to be exercised is bumped. Though not tracked in Maximo, it is estimated that about 50% of the valves exercised were bumped. HHWP has modified their preventive maintenance Maximo work order to include whether the valve was fully exercised or bumped.
