# State of the Regional Water System

Services of the San Francisco  
Public Utilities Commission

**September 2016**

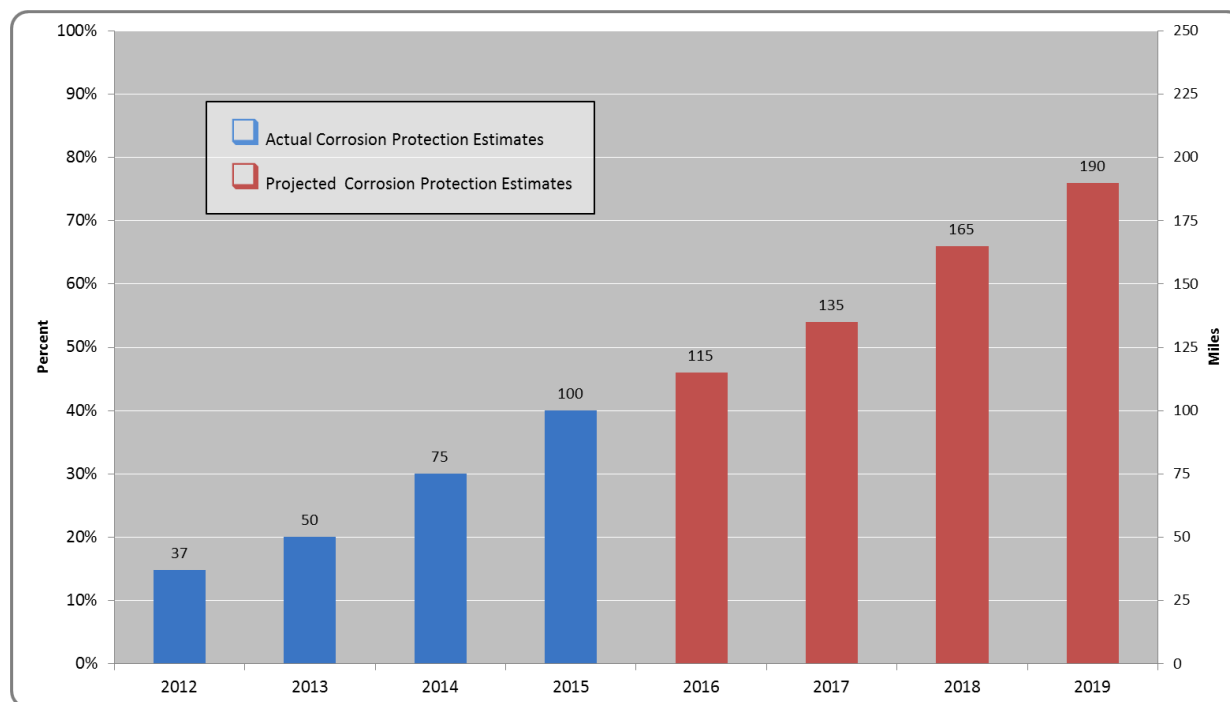
**Figure 4-2: Cathodically Protected Transmission Pipeline <sup>10</sup>**

improvements were estimated to be between \$18.3 and \$22.1 million in 2010. The WSTD started implementing the recommendations in FY11 and will continue to complete the repairs and improvements over the next 8 years. Projects that save the most money and protect the longest stretches of assets are implemented first. The scope of work is implemented over many years to reduce operational, construction, and staffing conflicts. Figure 4-2 summarizes the progression over time of CP on WSTD transmission pipelines.
