State of the Regional Water System

Hetch Hetchy
**Regional
Water
System**

Services of the San Francisco
Public Utilities Commission

November 2022

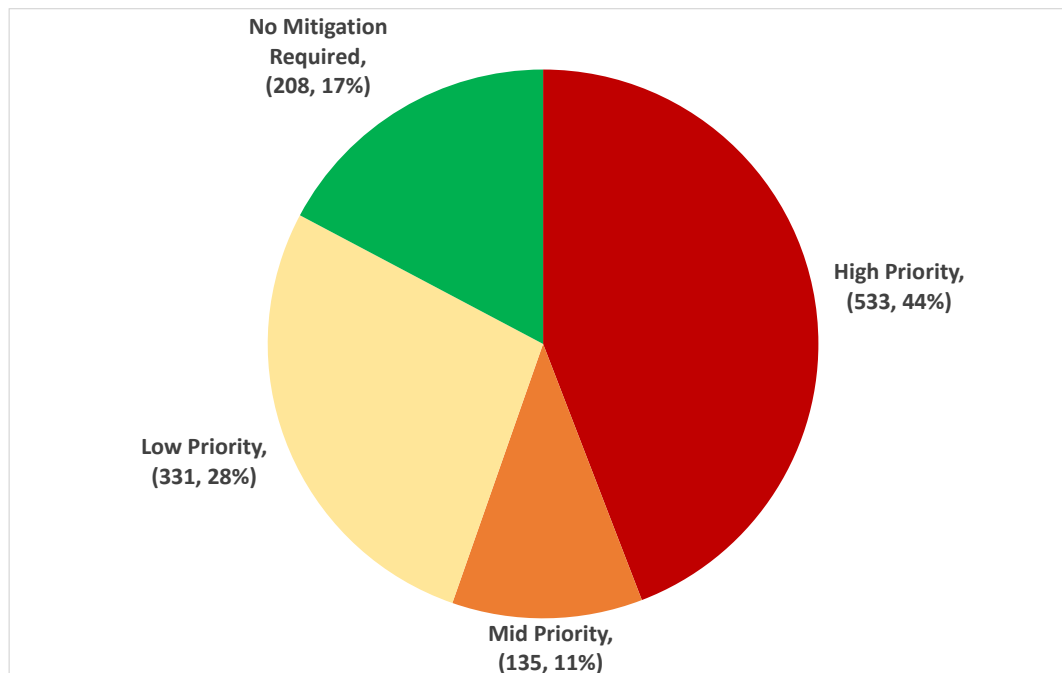
Figure 4-6: Mitigation Priority Breakdowns for BDPL Nos. 1 through 5; CSPL Nos. 1, 2, and 3; SSL; Sunol Region; and CSSAPL

The assessment reports include appurtenance information; noncompliance findings; the Federal Emergency Management Agency's 100-year flood level, where applicable; and mitigation recommendations. The report also lists appurtenances that do not meet the current standards; that are vulnerable to flooding due to urban development; and that have been added, removed, or modified and do not match reference data from GIS and Maximo used by SFPUC.

The site assessment surveys for BDPL Nos. 1, 2, 3, 4, and 5; CSPL Nos. 1, 2, and 3; SSPL; Sunol Region; and CSSAPL found that of the 1,207 appurtenances installed, 44 percent of the

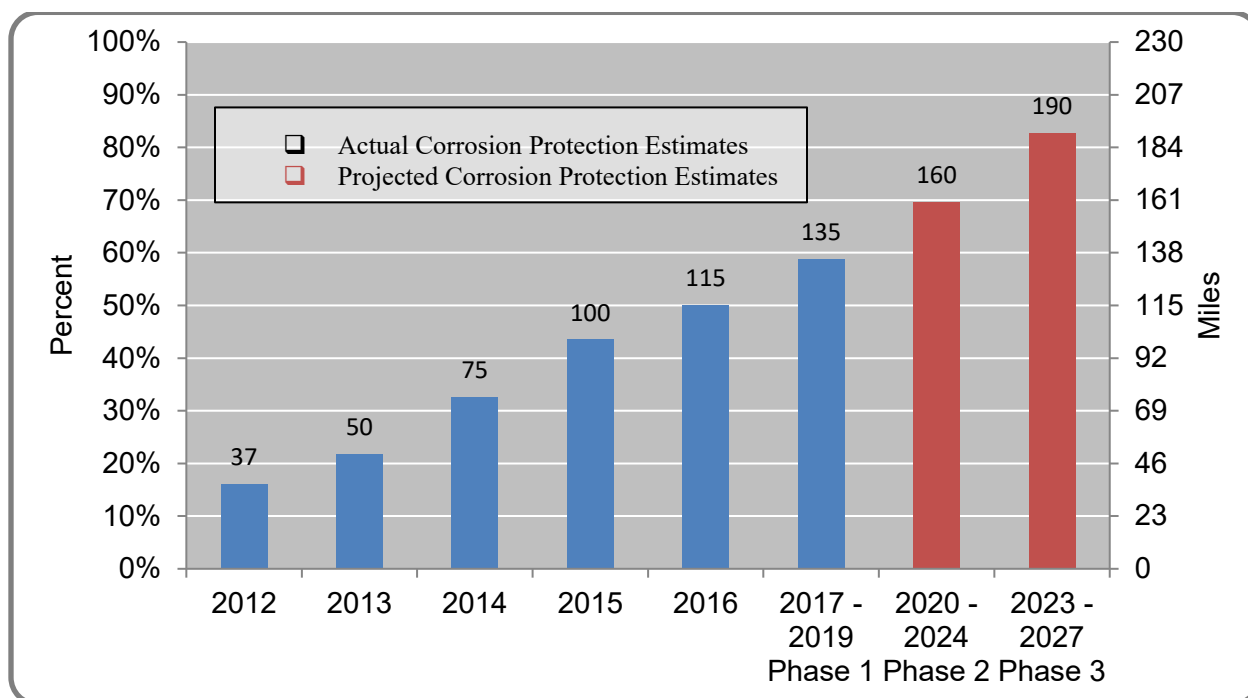
Figure 4-7: Cathodically Protected Transmission Pipeline²

inadequacies and provide improvements for ideal corrosion protection. The cost of repairs and improvements was estimated to be between \$18.3 and \$22.1 million in 2010. WSTD started implementing the recommendations in FY11, and have completed repairs and improvements over the last 10 years. Projects that save the most money and protect the longest stretches of assets are implemented first. The scope of work is implemented over many years to reduce operational, construction, and staffing conflicts. Coordination efforts include acquiring service agreements from the power utilities, determining the ROWs, permit reviews from local City jurisdictions along the Peninsula and East Bay, and outreach to adjacent property owners. Figure 4-7 summarizes the progression over time of CP on WSTD transmission pipelines.

The 2010 corrosion master plan identified corrosion potential and vulnerabilities from local ground conditions (e.g., corrosive soil or stray current) on 230 miles of transmission pipelines. With these field data, the study determined the adequacy of existing corrosion protection systems. Using those results, the study determined additional corrosion protection projects (including maintenance and monitoring work) that would most effectively and efficiently extend the remaining useful life of pipelines and buried assets.

In 2010, the condition assessment performed as a part of the master plan found that existing CP systems on the WSTD transmission lines were operating at less-than-adequate levels. Of the cathodically protected pipelines, only 15 percent of the linear length was adequately protected; the remaining 85 percent received only partial to no protection, leaving the pipeline subject to corrosion. Note that since the implementation of the 2010 corrosion master plan, CP of the transmission system has improved 5 to 10 percent annually.
