State of the Regional Water System

Services of the San Francisco
Public Utilities Commission

December 2024

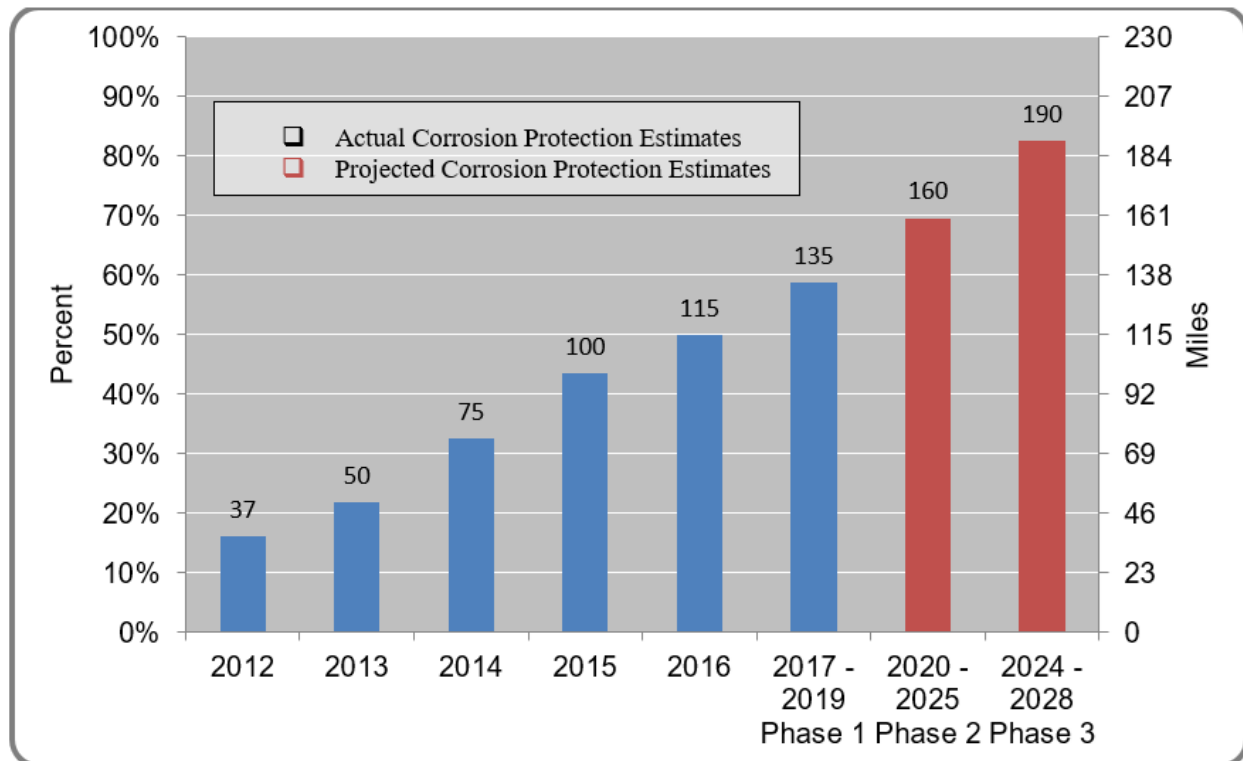
Figure 4-7: Cathodically Protected Transmission Pipeline¹

Prioritized projects derived from the plan were then sequenced in the CIP. The master plan first assessed transmission pipelines to determine the adequacy of corrosion protection of the existing system. Then the master plan made recommendations to repair inadequacies and provide improvements for ideal corrosion protection. The cost of repairs and improvements was estimated to be between \$18.3 and \$22.1 million in 2010. WSTD started implementing the recommendations in FY11, and have completed repairs and improvements over the last 14 years. Projects that save the most money and protect the longest stretches of assets are implemented first. The scope of work is implemented over many years to reduce operational, construction, and staffing conflicts. Coordination efforts include acquiring service agreements from the power utilities, determining the ROWs, permit reviews from local City jurisdictions along the Peninsula and East Bay, and outreach to adjacent property owners. Figure 4-7 summarizes the progression over time of CP on WSTD transmission pipelines.

The condition assessment performed as a part of the master plan found that existing CP systems on the WSTD transmission lines were operating at less-than-adequate levels. Of the cathodically protected pipelines, only 15 percent of the linear length was adequately protected; the remaining 85 percent received only partial to no protection, leaving the pipeline subject to corrosion. Note that since the implementation of the 2010 corrosion master plan, CP of the transmission system has improved 5 to 10 percent annually.
